# **UltraScan CD**

## **Final Report**

Project: 121,8 mi x 12"  
Hattisburg Station – Demopolis Station

Client: Dixie Pipeline Company  
United States

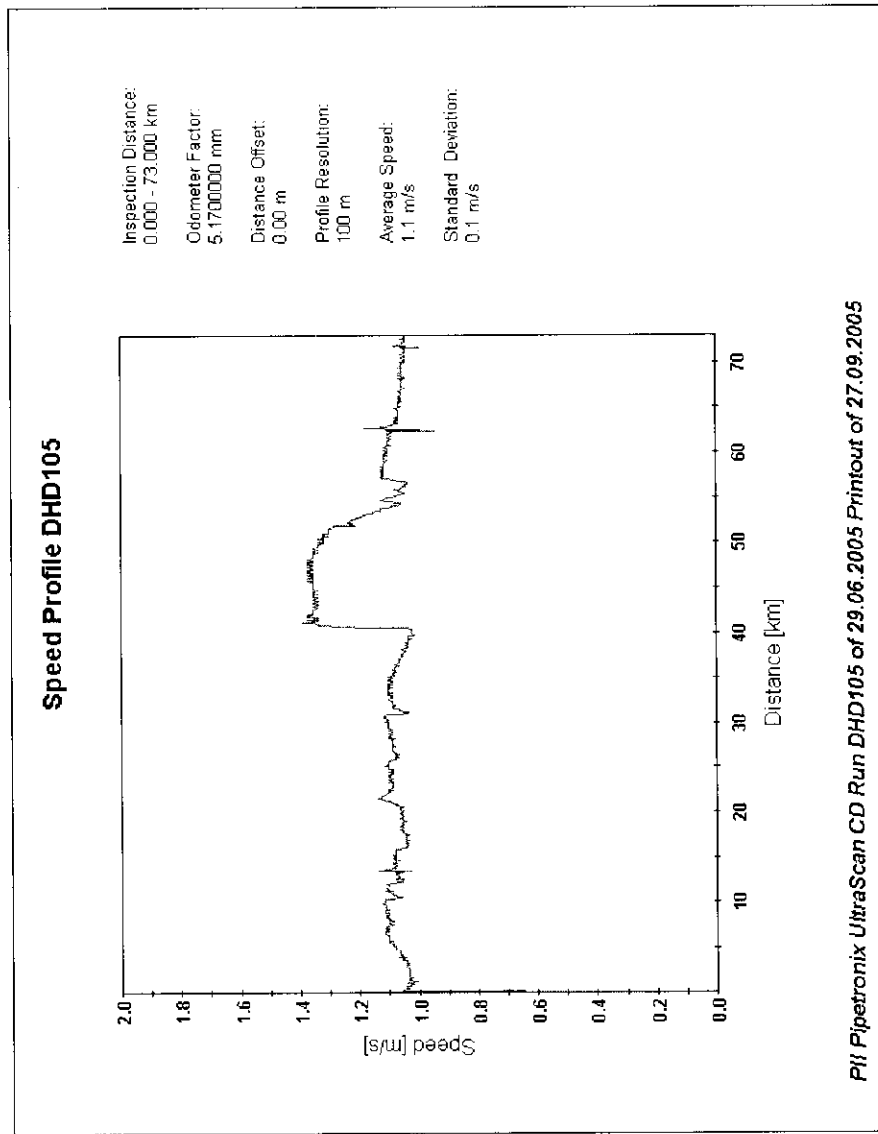
During the inspection run DHD105 the average tool speed was approximately 3.61 ft/s with only marginal deviations, i.e. during the inspection the tool was operating in the time-trigger mode providing the optimum axial resolution.

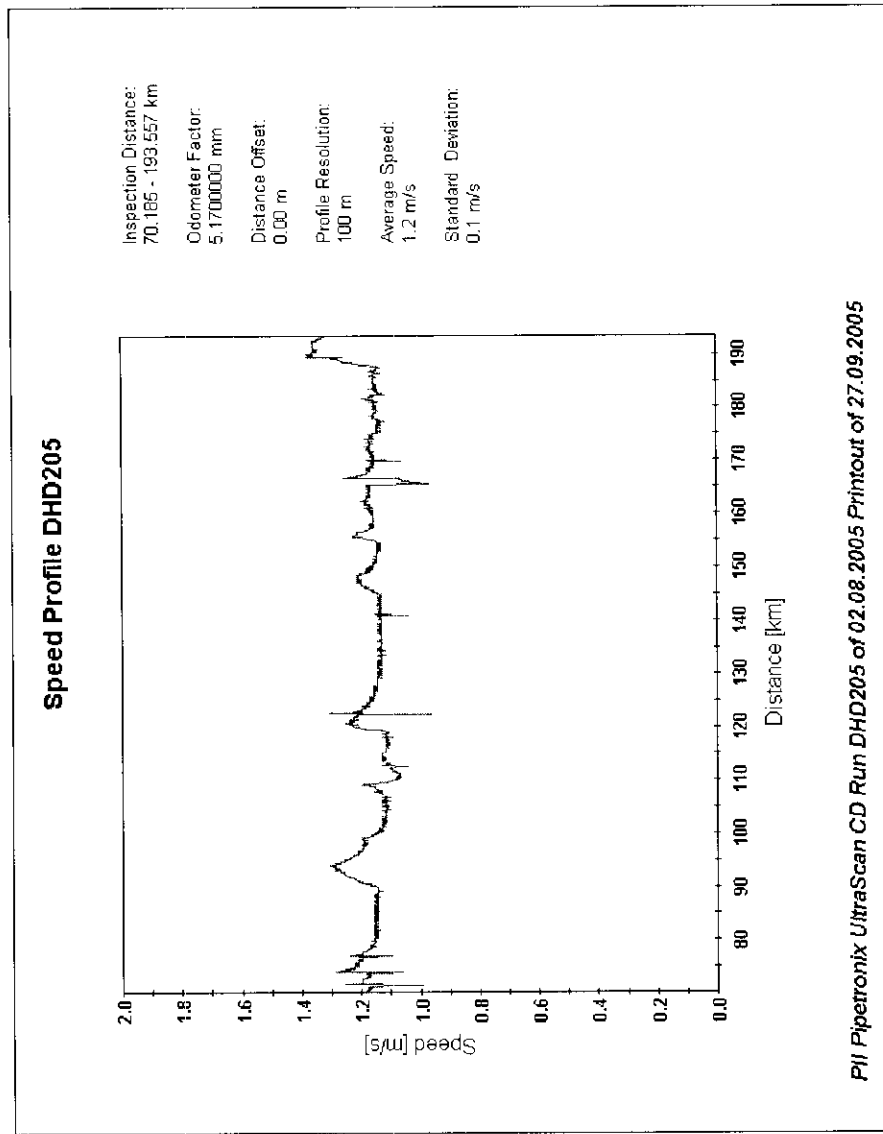
During the inspection run DHD205 the average tool speed was approximately 3.93 ft/s with only marginal deviations, i.e. during the inspection the tool was operating in the time-trigger mode providing the optimum axial resolution.

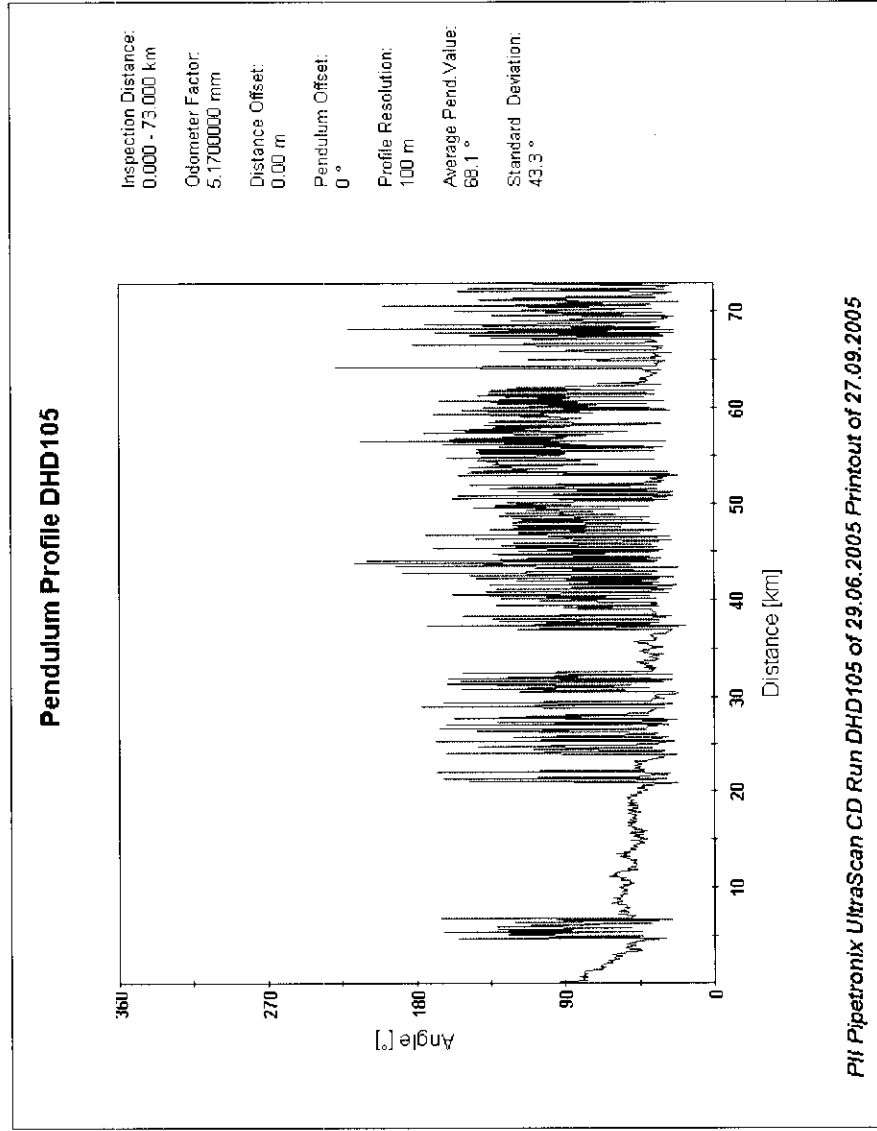
The pendulum profile shows the rotational movement of the pig during the inspection run. For the inspection run DHD105 the mean deviations are  $\pm 43^\circ$  as can be seen from the attached pendulum profile.

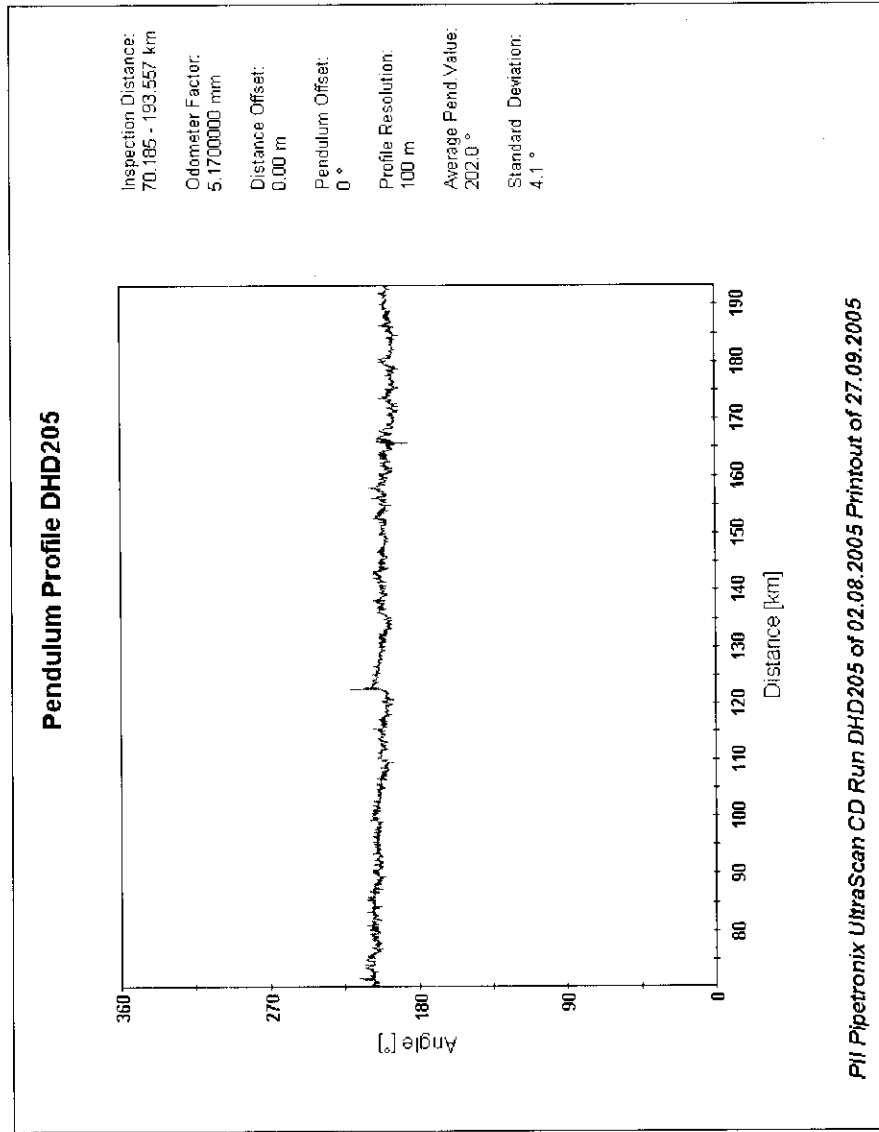
For the inspection run DHD205 the mean deviations are  $\pm 4^\circ$  as can be seen from the attached pendulum profile.
